#### LIGHTWEIGHT STRUCTURES in CIVIL ENGINEERING CONTEMPORARY PROBLEMS

# DETERMINING PROPERTIES OF POLYUREA COATINGS AS A MATERIAL POTENTIALLY STRENGTHENING STRUCTURAL ELEMENTS

J. Szafran 1) A. Matusiak 2)

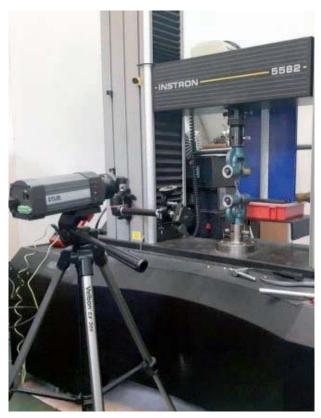
Fig. 2. Tensile strength test of polyurea - test bench.

Basic properties of polyurea coatings were determined for aromatic polyurea as the most common type of coating utilized in the construction industry. Basic tests were designed to determine mechanical properties of polyurea in terms of static tension according to EN ISO 527:2012. The tests were done to evaluate tensile strength of polyurea using dumbbell-shaped samples. The tensile strength of the material was determined for three test speeds of 50, 100, and 500 mm/min on a custom test bench (Fig. 2). All tensile tests were done on the INSTRON 5582 tensile tester. The results of polyurea tensile tests are shown in Figure 3 and Table 1.

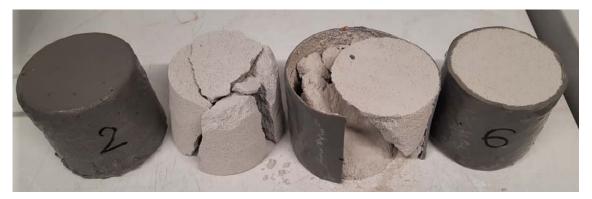
All the specimens failed in a characteristic conical way similar to that of concrete specimens in compression strength tests (Fig. 8). In contrast to control samples (type I), the polyurea-coated specimens (types II and III) kept their integrity after the maximum load was exceeded.

Fig. 8. Cellular concrete samples after the failure.
